# **Hemel en Aarde Wellfields Expansion Project**

***HAV1 Repl. and T4/5 Pipelines and Pumphouse  
Construction – Section 21(c) and (i) Water Use Licence  
Conditions Monitoring Report January –September 2025***

**UMVOTO REPORT NUMBER** : 972/5/1/2025

**DATE** : December 2025

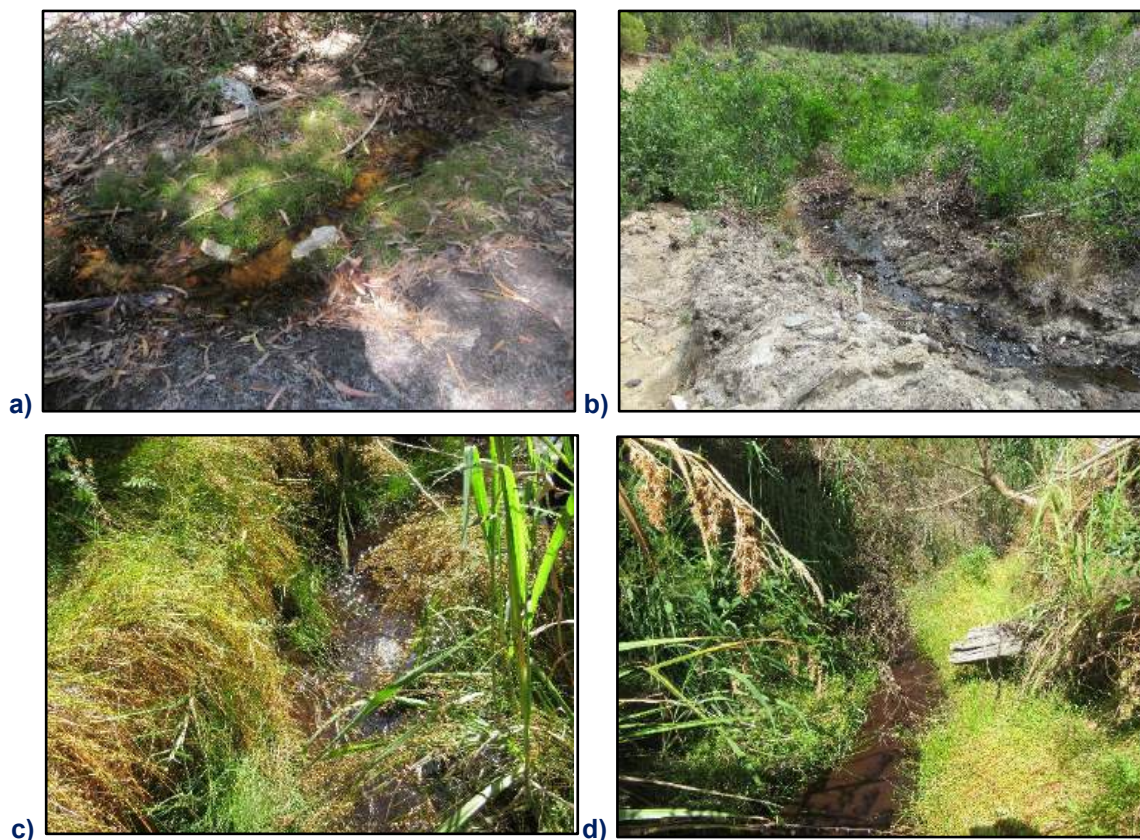
**Figure 3-2** Onrus River tributary reaches sampled upstream and downstream (respectively) of the proposed HAV1 Repl. (a) and (b) and T4/5 (c) and (d) production borehole construction activities locations for water quality and SASS5 bio-monitoring.

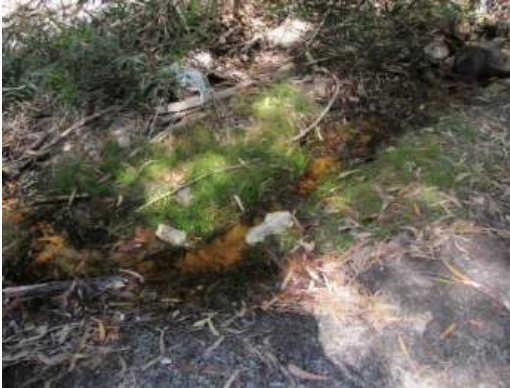
**Table 1: Results of the assessment at site HAV1 (located upstream) of the Hemel en Aarde catchment.**

| Site HAV1 (US) | | In situ physico-chemical water quality | | | | Aquatic macro-invertebrate community integrity | | | |
| | pH | 5.33 | pH | NA | SASS5 score | 73 | SASS5 | NA (No upstream spatial reference) | |

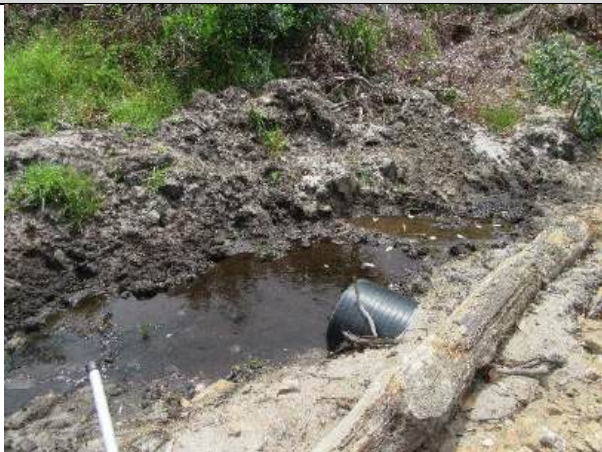
**Table 2: Results of the assessment at site HAV1 (located downstream) of the Hemel en Aarde catchment.**

| Site HAV1 (DS) | | In situ physico-chemical water quality | | | | Aquatic macro-invertebrate community integrity | | | |
| | pH | 4.92 | pH | -8.0 | SASS5 score | 42 | SASS5 | -42.0 | |

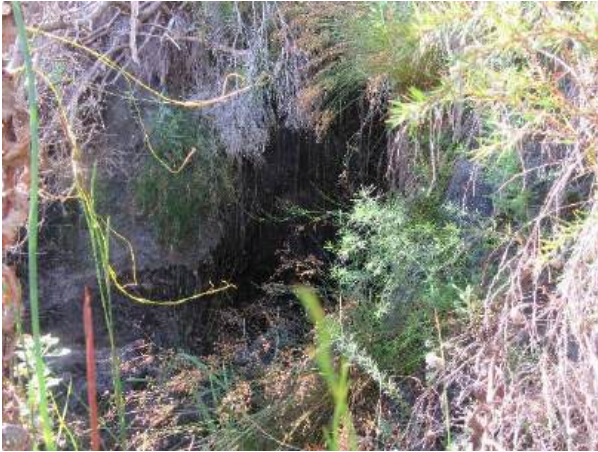
**Table 3: Results of the assessment at site T4/5 (located upstream) of the Hemel en Aarde catchment.**

| Site T4/5 (US) | | In situ physico-chemical water quality | | | | Aquatic macro-invertebrate community integrity | | | |
| | pH | 6.54 | pH | NA | SASS5 score | 49 | SASS5 | NA (No upstream spatial reference) | |

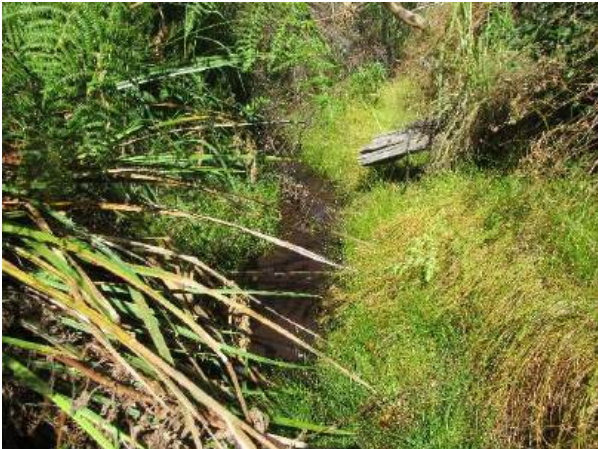
Table 4: Results of the assessment at site T4/5 (located downstream) of the Hemel en Aarde catchment.

| Site T4/5 (DS) | | In situ physico-chemical water quality | | | | Aquatic macro-invertebrate community integrity | | | |
| | pH | 6.06 | pH | -7.0 | SASS5 score | 85 | SASS5 | +73.0 | |

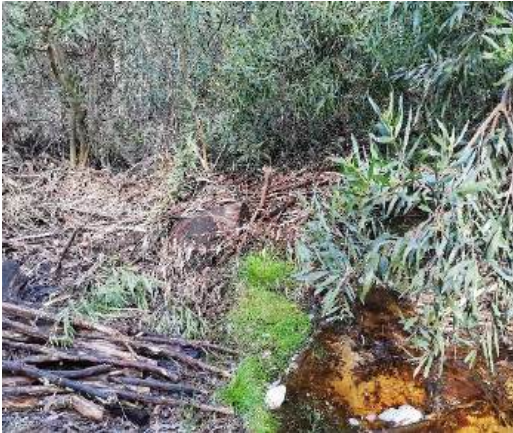
**Table 1: Results of the assessment at site HAV1 Replacement (located upstream) of the Hemel en Aarde catchment.**

| Site HAV1 (US) | | In situ physico-chemical water quality | | | | Aquatic macro-invertebrate community integrity | | | |
| | pH | 4.94 | pH | NA | SASS5 score | 66 | SASS5 | NA (No upstream spatial reference) | |

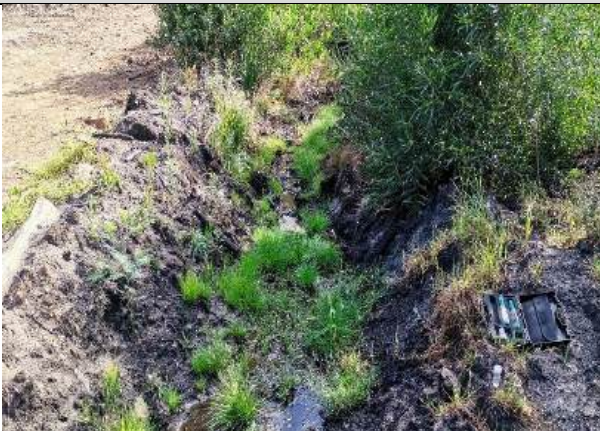
**Table 2: Results of the assessment at site HAV1 Replacement (located downstream) of the Hemel en Aarde catchment.**

| Site HAV1 (DS) | | In situ physico-chemical water quality | | | | Aquatic macro-invertebrate community integrity | | | |
| | pH | 4.58 | pH | -7.3 | SASS5 score | - | SASS5 | - | |

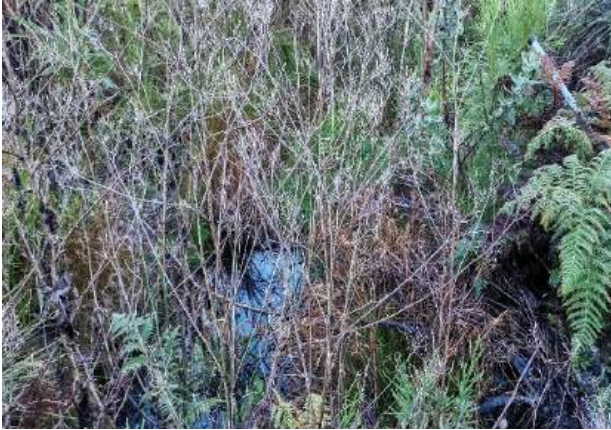
**Table 3: Results of the assessment at site T4/5 (located upstream) of the Hemel en Aarde catchment.**

| Site T4/5 (US) | | In situ physico-chemical water quality | | | | Aquatic macro-invertebrate community integrity | | | |
| | pH | 5.51 | pH | NA | SASS5 score | 25 | SASS5 | NA (No upstream spatial reference) | |

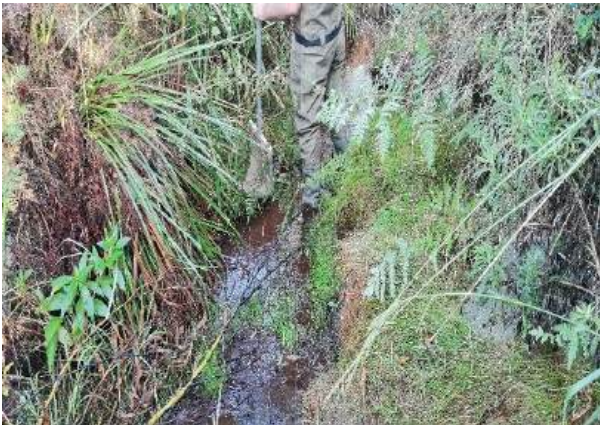
**Table 4: Results of the assessment at site T4/5 (located downstream) of the Hemel en Aarde catchment.**

| Site T4/5 (DS) | | In situ physico-chemical water quality | | | | Aquatic macro-invertebrate community integrity | | | |
| | pH | 5.54 | pH | +0.5 | SASS5 score | 61 | SASS5 | +144.0 | |

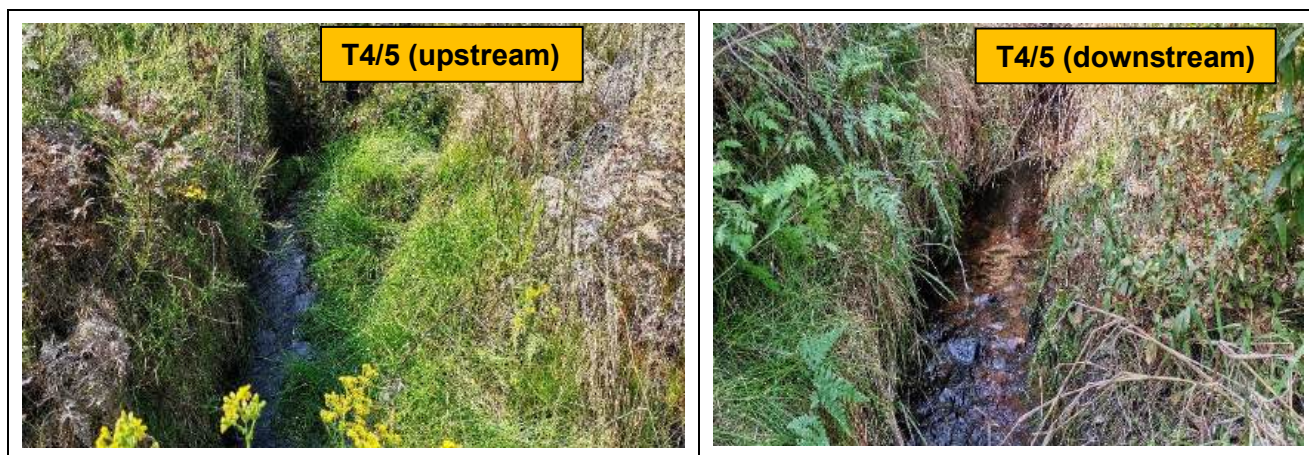
**T4/5 (downstream):** This downstream river reach, by comparison, accommodated a much more diverse SASS5 sampling habitat consisting of runs, riffles, pools, and backwaters. Discharge at this site was significantly greater compared to the upstream site, with the river being ~ 1.5 m wide and 0.2 m deep. Although erosion was still very evident at this site, the marginal vegetation out of current was still intact, which provided a good SASS vegetation sampling habitat. Visually the water quality improved significantly at this site and was a clear light brown colour and is considered to be of a very good quality. As with previous assessments, the hydraulic biotopes were regarded as good. Cobbles at the site become increasingly covered with organic material and is likely due to a general decrease in baseflows over the summer season.

**Figure 2: River reaches sampled upstream and downstream of the HAV1 Replacement and T4/5 production borehole locations.**

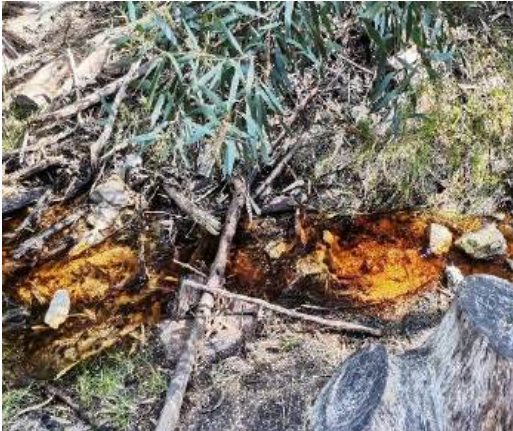
**Table 1: Results of the assessment at site HAV1 Replacement (located upstream) of the Hemel en Aarde catchment.**

| Site HAV1 (US) | | In situ physico-chemical water quality | | | | Aquatic macro-invertebrate community integrity | | | |
| | pH | 4.54 | pH | NA | SASS5 score | 71 | SASS5 | NA (No upstream spatial reference) | |

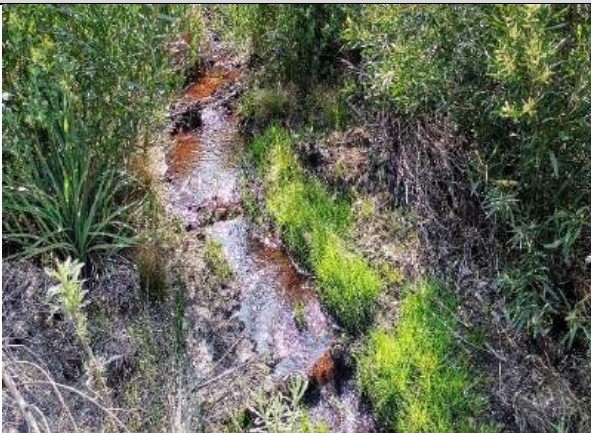
**Table 2: Results of the assessment at site HAV1 Replacement (located downstream) of the Hemel en Aarde catchment.**

| Site HAV1 (DS) | | In situ physico-chemical water quality | | | | Aquatic macro-invertebrate community integrity | | | |
| | pH | 4.33 | pH | -4.6 | SASS5 score | 56 | SASS5 | -21.0 | |

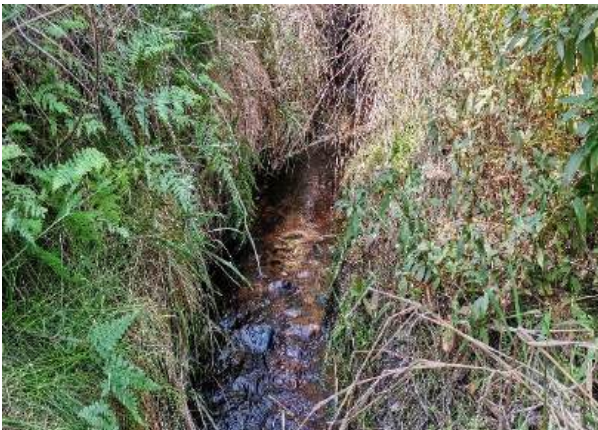
**Table 4: Results of the assessment at site T4/5 (located downstream) of the Hemel en Aarde catchment.**

| Site T4/5 (DS) | | In situ physico-chemical water quality | | | | Aquatic macro-invertebrate community integrity | | | |
| | pH | 4.43 | pH | -4.7 | SASS5 score | 53 | SASS5 | -43.6 | |
